Navajo AUM Project

Navajo Abandoned Uranium Mine Site Screen Report

Haystack No. 1 AUM Site

Weston Solutions, Inc.

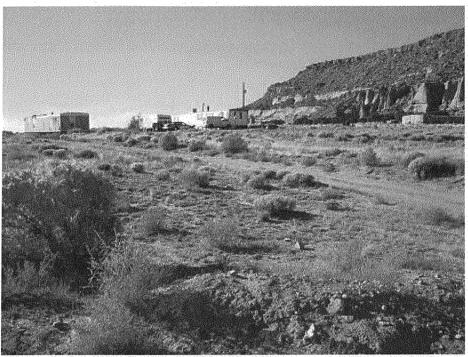
At what distance from the cap/seal is the nearest domestic structure located? One residence is located on the mine; two others are located within ¼ mile. A church is also located within ¼ mile from the site.

Photo 3. Haystack No 1 Mine site, residence (Tom and LeneaVandever) locate on the mine site

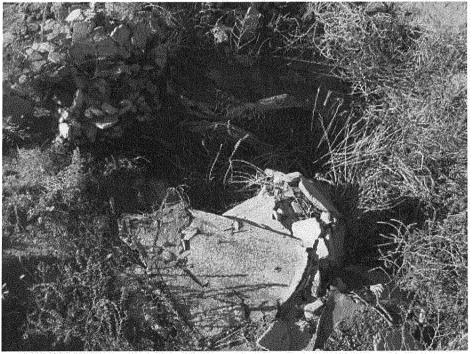
Photo 4. Haystack No 1 Mine site, open hole or vent near residence

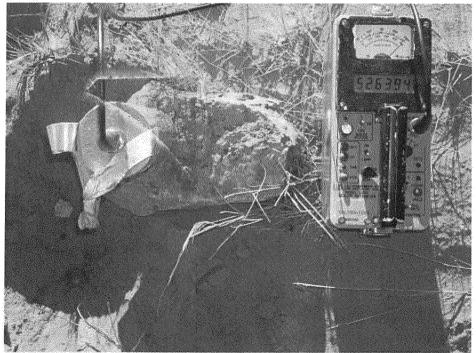
Photo 6. Haystack No 1 Mine site, gamma radiation emitting 500,000 cpm from waste rock located near residence

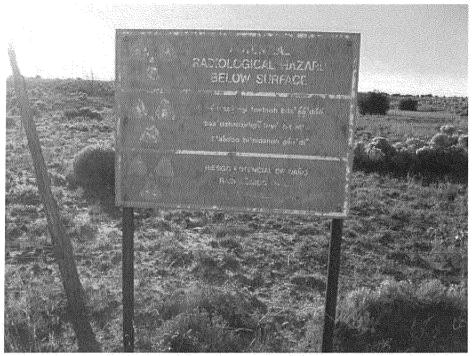
Reclamation status of the mine sites are currently unknown. The mine appears to have been reclaimed. The portion of the mine on private property was fenced and posted with signs warning of underground radiological hazards. The signs were faded and nearly illegible. No adits or other mine features were observed during the site visit.

Photo 6. Haystack No 1 Mine site, faded sign posted on portion of mine located on private property warning of subsurface radiological hazards

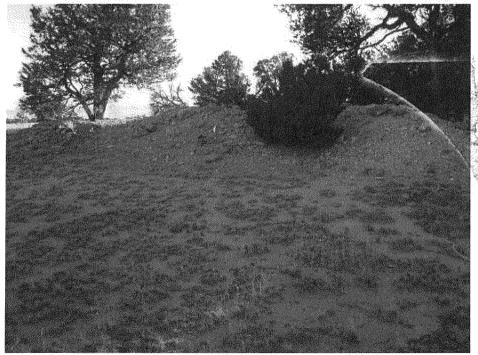
Photo 6. Haystack No 1 Mine site, waste piles on mine

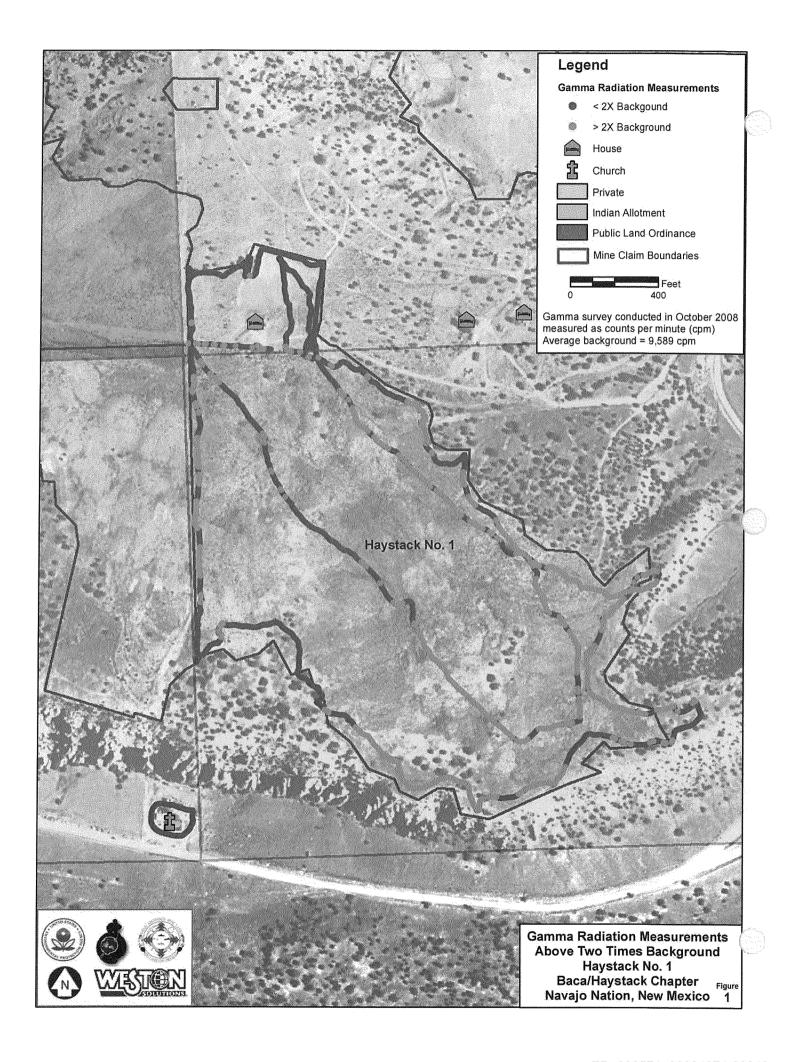
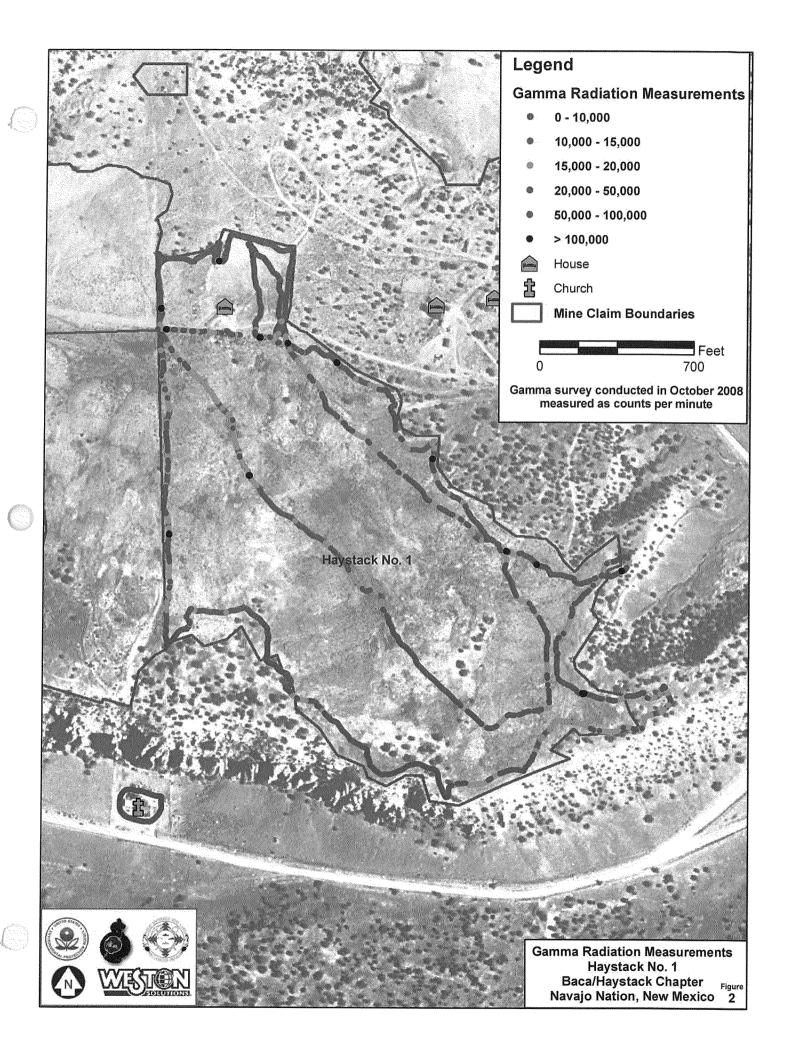
Mine site: Haystack No. 1 - See Figures 1 and 2

A total of 7,045 gamma radiation measurements were collected from mine sites, ranging from 5,965 cpm to 626,434 cpm. The measurements are represented in Figures 1 and 2.
